Former Huskisson Anglican Church

Statement of Heritage Significance

Prepared for Shoalhaven City Council

May 2023 - FINAL

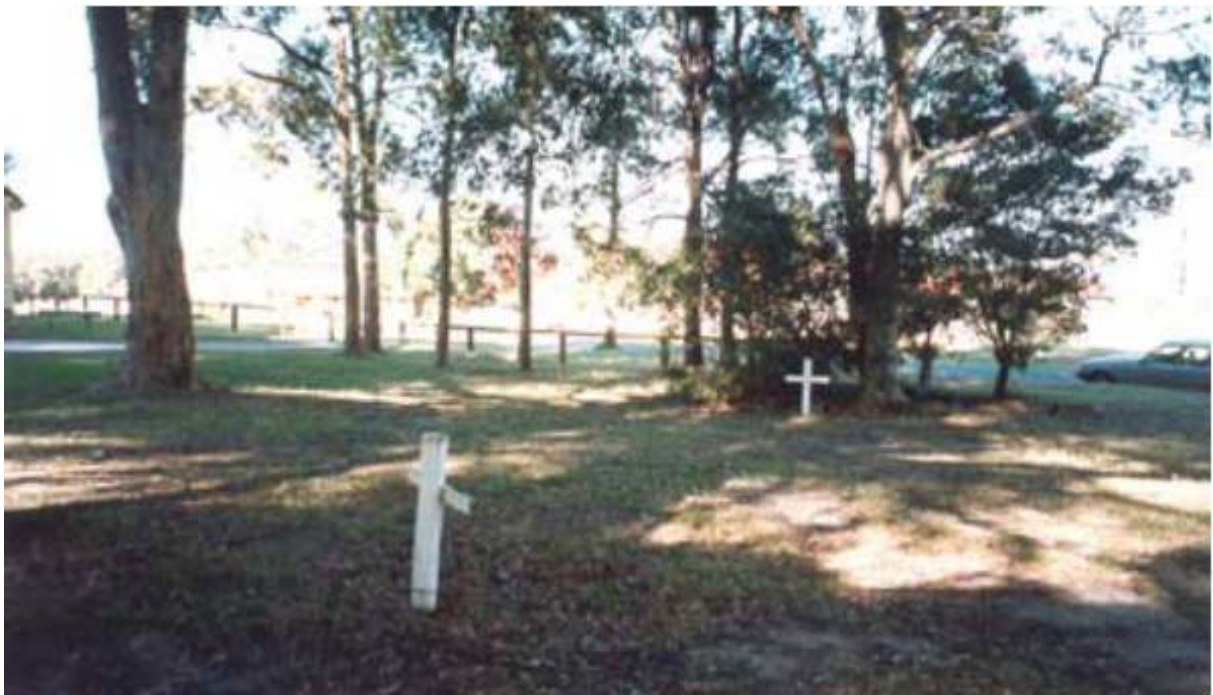
Figure 20. Grave markers on Lot 9. *Source:* Shoalhaven Heritage Inventory, Huskisson Holy Trinity Anglican Church Group, SHI Number 2390385.

In the late twentieth century, two grave markers were present on Lot 9 (Figure 20). It is not known when, or by whom, the crosses were installed and later removed. Details about the identity and date of potential burials at the site have been investigated in detail in previous assessments.

Lot 9 is a roughly square shaped allotment belonging to the Jerrinja Local Aboriginal Land Council. The allotment comprises relatively flat turfed ground with numerous mature trees. In the late twentieth century, several white wooden crosses were located on the site (refer Figure 20).

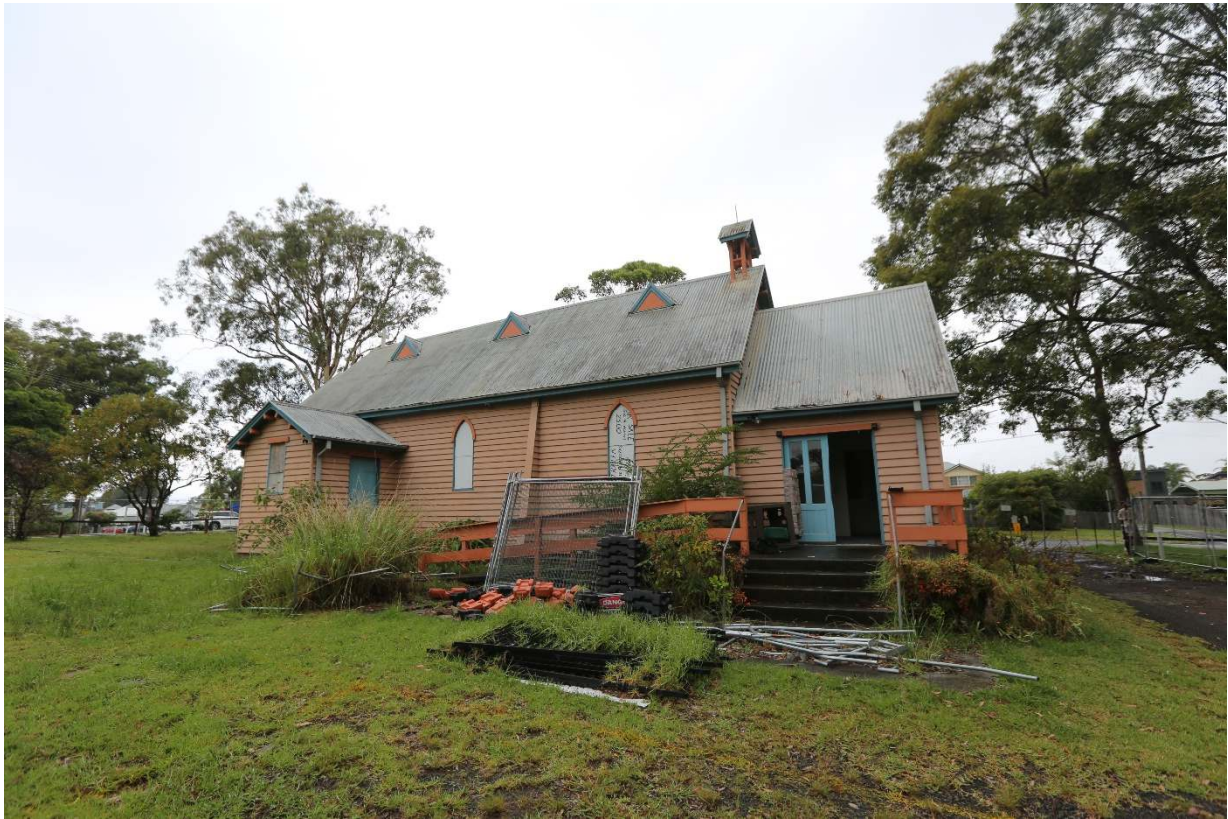
Figure 21. Northern elevation.

The northern elevation has one timber buttress, and the southern elevation has two timber buttresses. The church has lanceolate windows along the northern, eastern, and southern elevations. The porch has similar lanceolate windows, though these are more squat in form. The vestry has a rectangular window. Most windows are currently boarded over, with the exception of one window on the southern elevation, which is protected by wire.

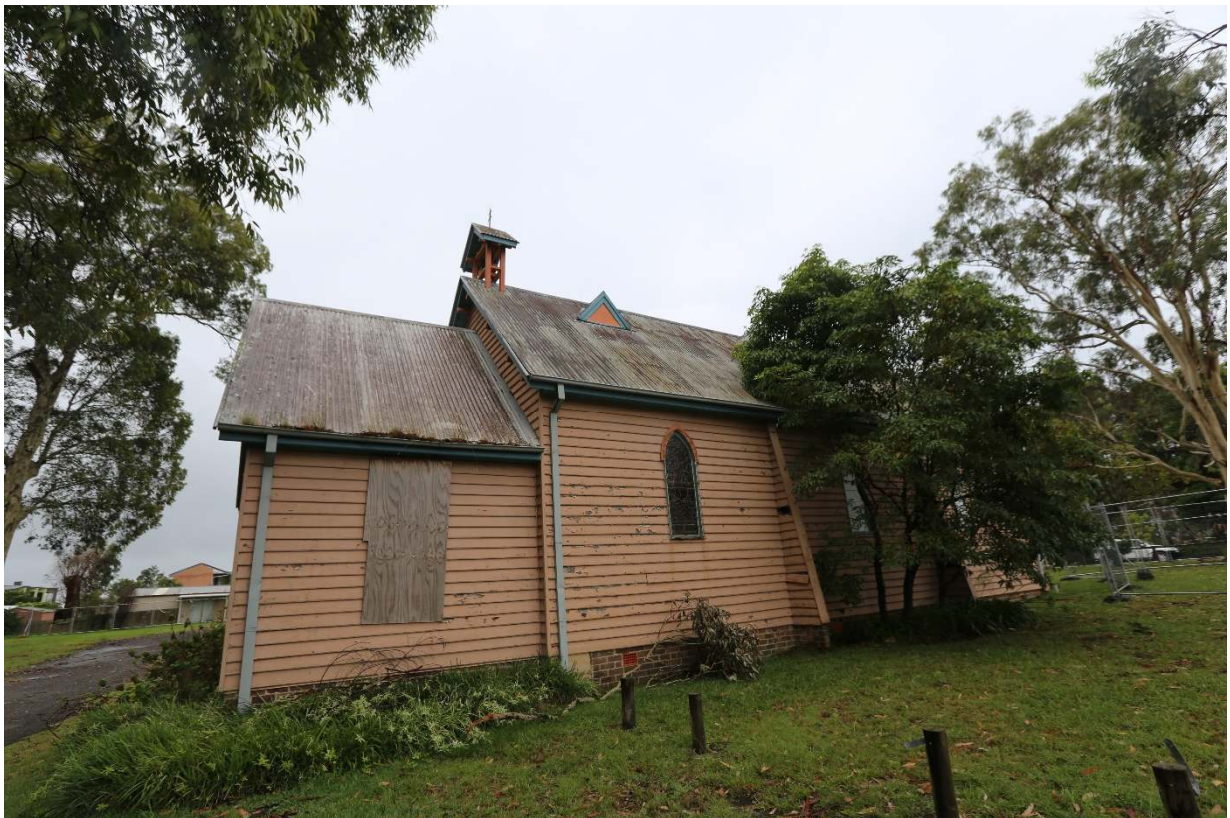
Figure 24. Southern elevation.

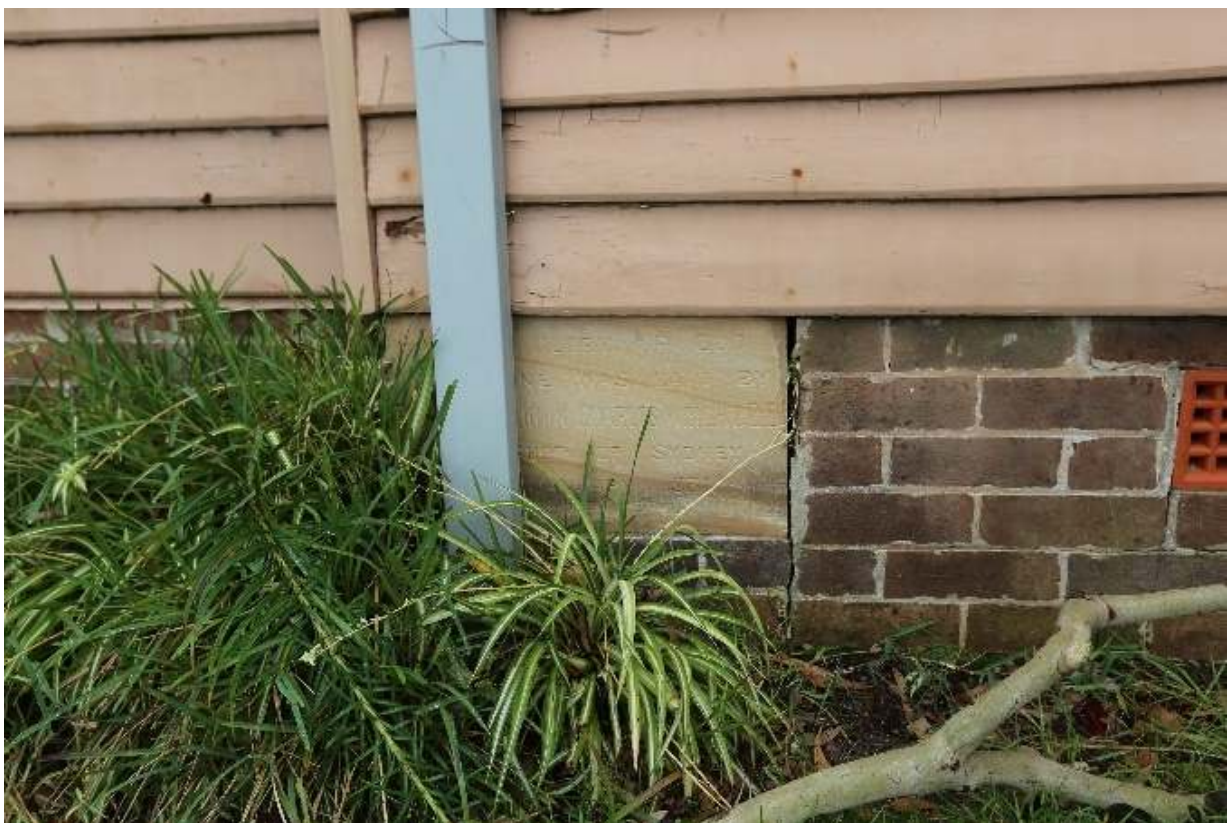
Figure 26. Foundation stone.

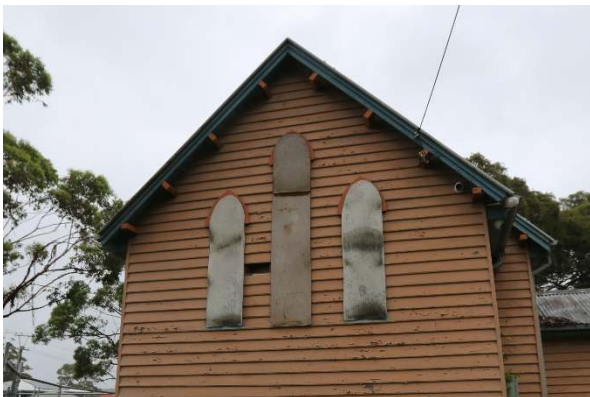
Figure 44. Damaged cladding to eastern elevation.

External paintwork was observed to be flaking across several areas, particularly to the eastern and southern elevations. External cladding is damaged or missing in several areas, including to the eastern elevation, the south-eastern corner, and the southern elevation (Figure 44-Figure 46). Internal walls, ceiling and flooring are in good condition. Windows to the western porch have broken glazing (Figure 47).

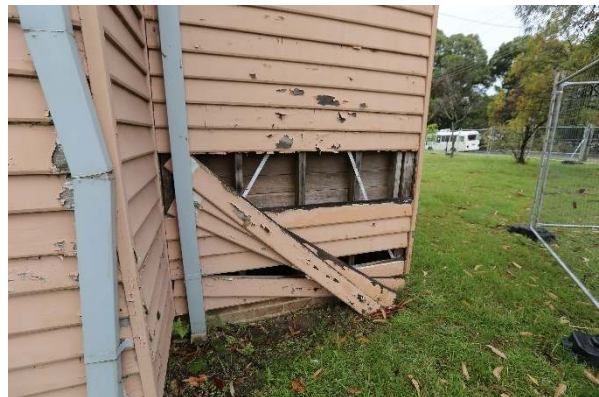
Figure 45. Damage to cladding at south-eastern corner.

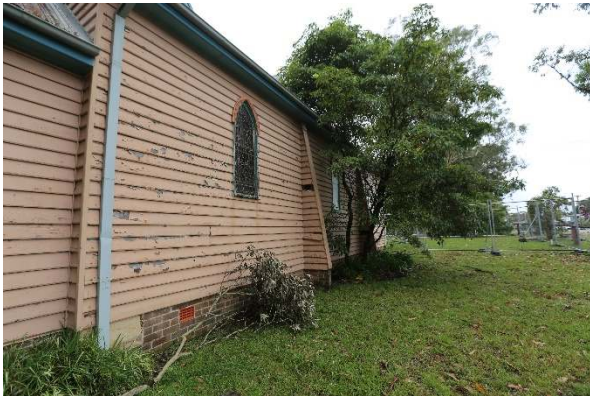
Figure 46. Flaking paint and damaged cladding to southern elevation.

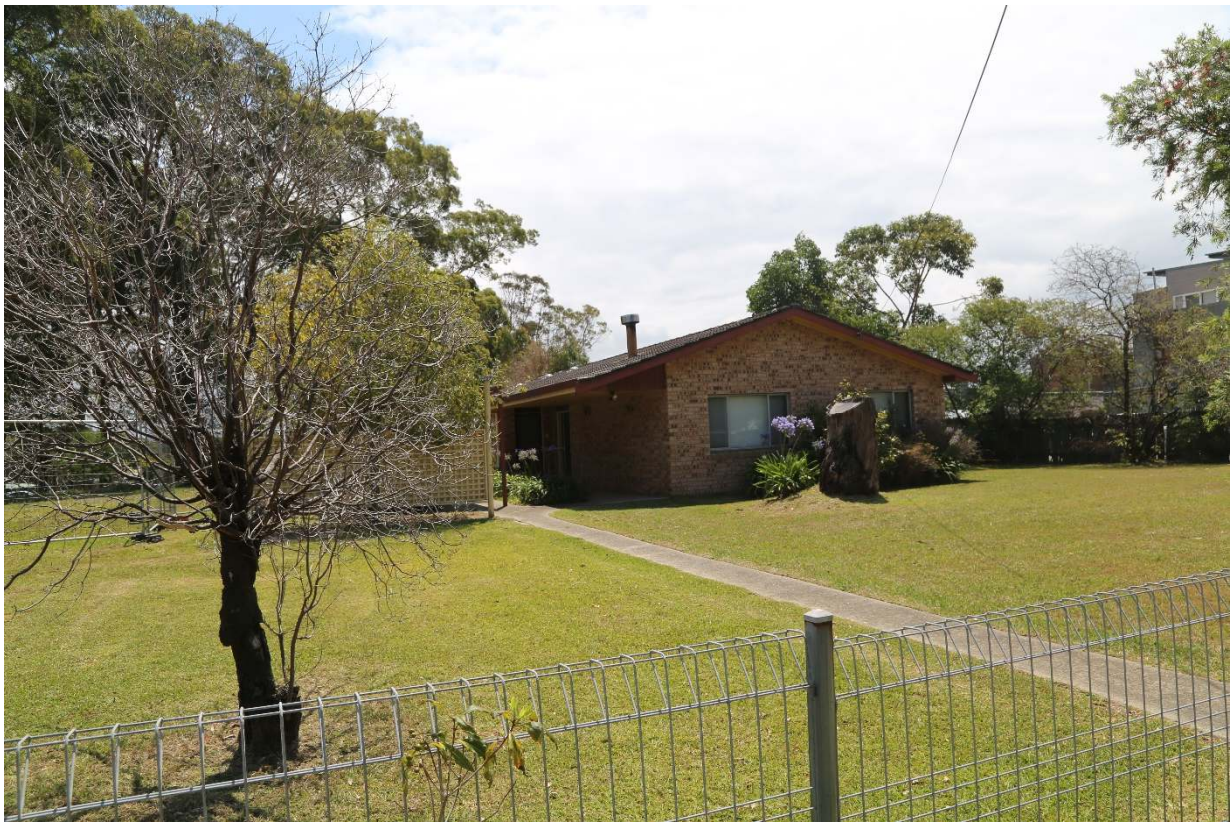
Figure 48. Rectory building.

The rectory building at the north-east of the site is a single storey brick structure. It is located on the site of the original church, which was relocated in 1979. The rectory building was completed in 1980.. It is rectangular in layout, with a recessed entry to the south-east of the building. The roof overhangs the recessed entry way.

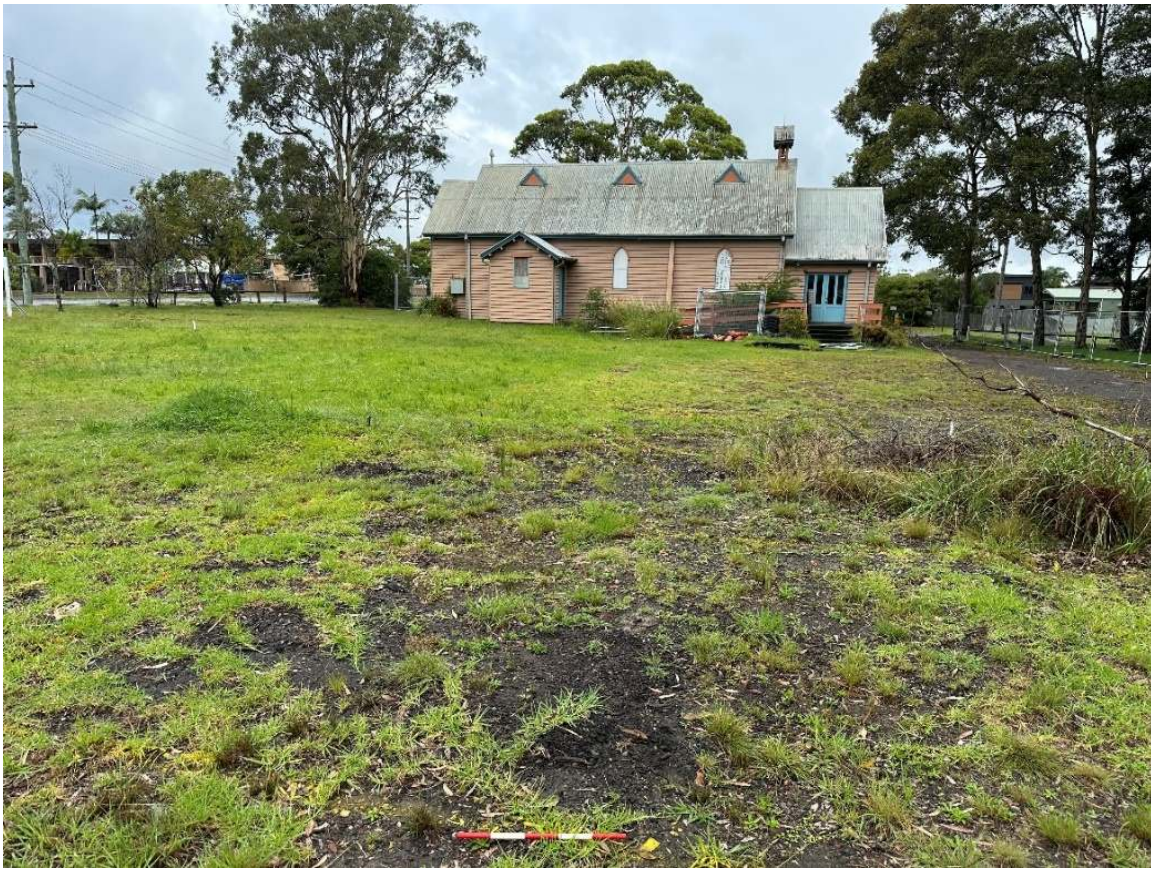
Figure 51. View through Lot 7, facing south.

- No archaeological features were identified above the ground surface.
- The church is located on the southern portion of Lot 7 (Figure 52).
- Lot 7 sloped was relatively level with a gentle slope down to the south (Figure 51).

- The majority of the ground surface in Lot 7 was covered with low, mown grass and leaf cover. As a result, the visibility was 0–30 per cent (Figure 51 and Figure 52).

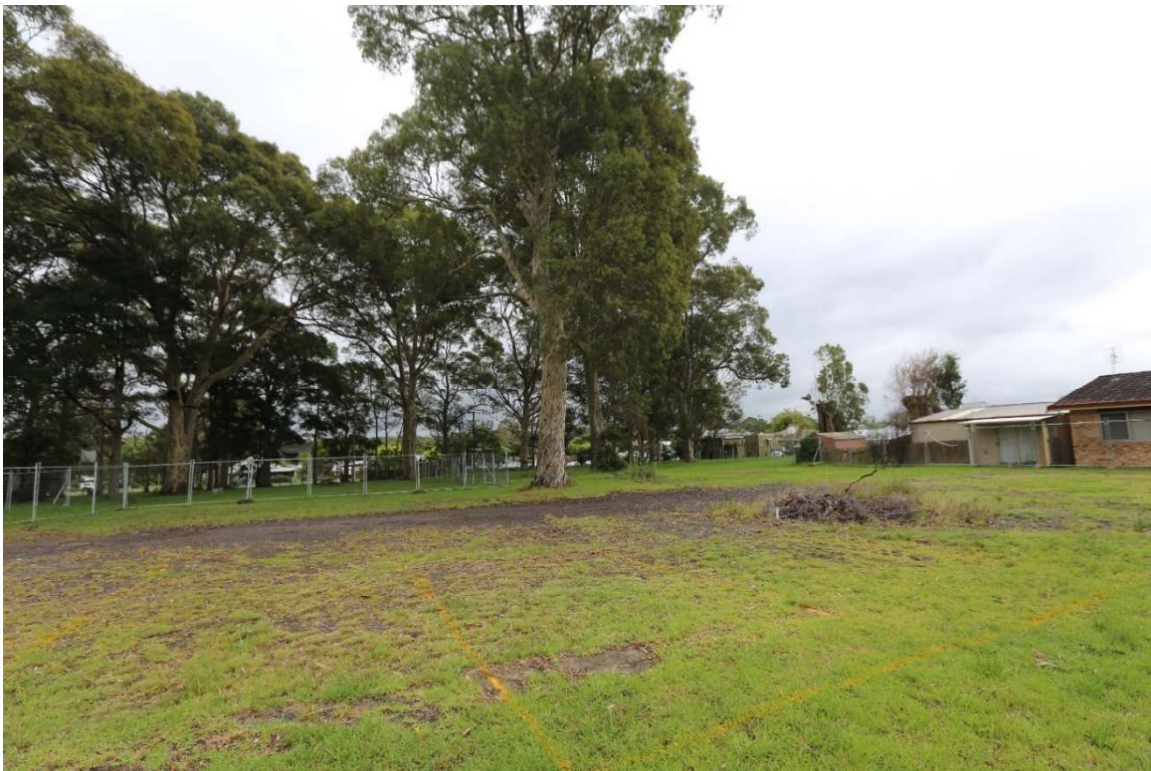
Figure 52. View through Lot 7, facing north-west.

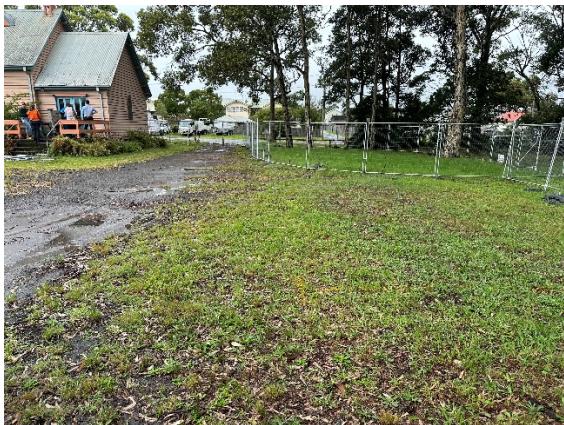
Figure 53 Ground disturbance from gravel road running north to south through Lot 7, facing south.

- A gravel roadway, running north to south, was located on the western portion of Lot 7 (Figure 53 and Figure 54). The road was cut down from the current ground level.

- The clearance of the ground for the gravel road installation was considered an area of disturbance.
- Ground disturbance for the construction of the church was also apparent in the form of foundations/footings.

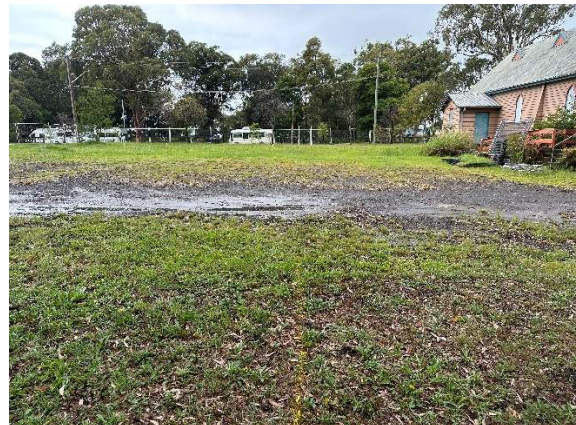
Figure 54. Gravel road running north to south through Lot 7, cut down from ground level on either side, facing east.

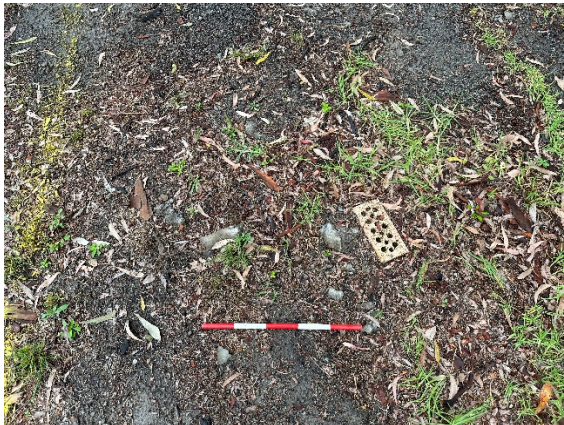
Figure 55. Example of modern brick, asphalt, and large stones deposited on and around the gravel road running north to south through Lot 7.

- Modern brick, gravel, and larger stones were found across the length of the road, and at the termination of the road (Figure 55). The visibility of the gravel road surface was 100 per cent.

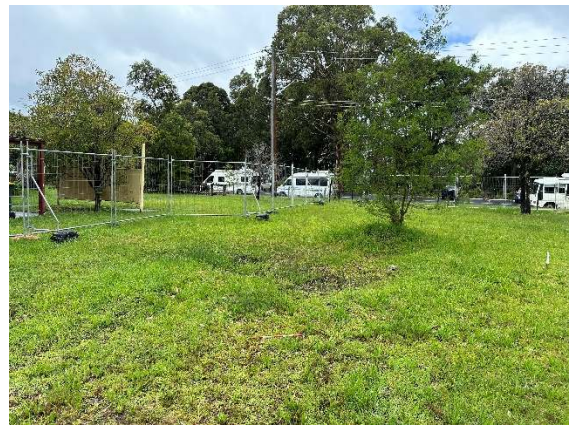
Figure 56. Ground disturbance (shallow pit with soil piled around edge) in north-eastern portion of Lot 7, facing north-west.

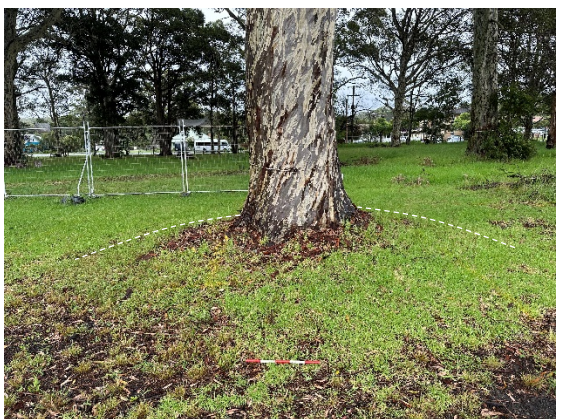
Figure 57. Example of humic deposits and roots creating a rise around large trees (white dashed line), facing west.

- Raised earth (likely caused by humic deposits and bioturbation) was identified around the base of larger trees (Figure 57).
- Ten micro rises of the ground surface across the northern portion of the site were identified. The extent of the rises were circular or oval in shape and measured approximately 4 m by 2–4 m. The spacing between the features varied.
- Undulating micro rises were identified across the northern portion of the site, from the northern and eastern boundary of Lot 7, and to the gravel road on the western boundary of Lot 7. These features were not identified on the southern side of the church structure. The micro rises were relatively uniform in size and alignment. Due to their small height and the grass cover, other micro rises may be located across the lot that were not immediately visible during the site visit.

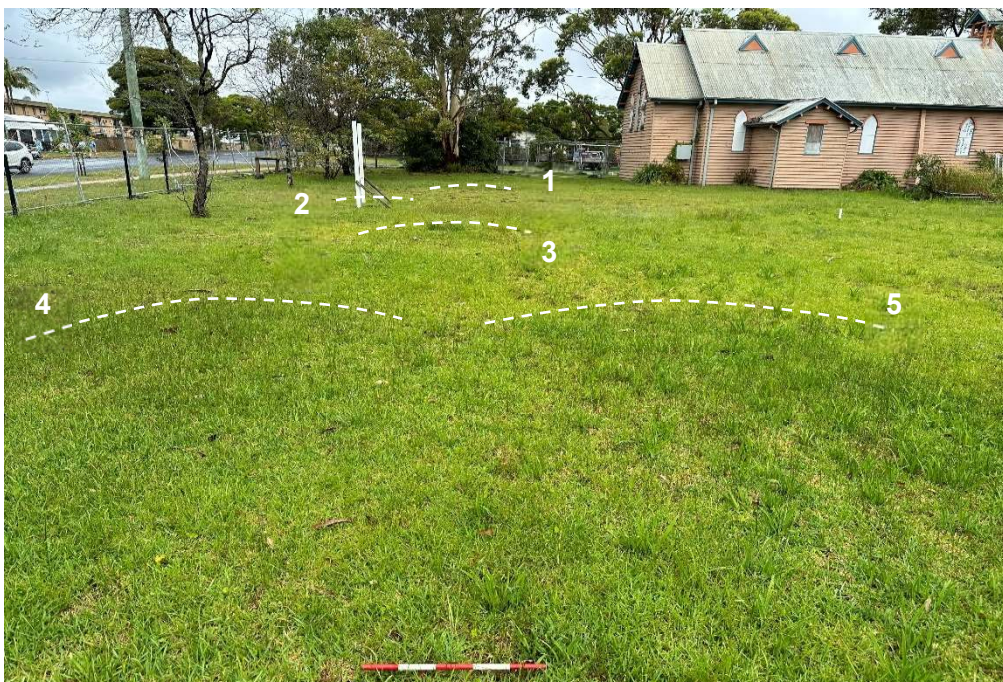
Figure 59. Examples of micro-rises of the ground surface (white dashed line) (width shown) in the northern portion of Lot 7, facing south.

The 2019 demolition of the old church and the shed has caused significant disturbance to the upper soil profiles. The ground scouring is clear on the 2019 aerial (Figure 18). The micro rises identified during the site inspection on 5 March 2023 (Figure 58 to Figure 61) would have been created by or after the demolition event. It is highly likely that machine movement of soil the likely cause for the small gradual rises visible under the grass.

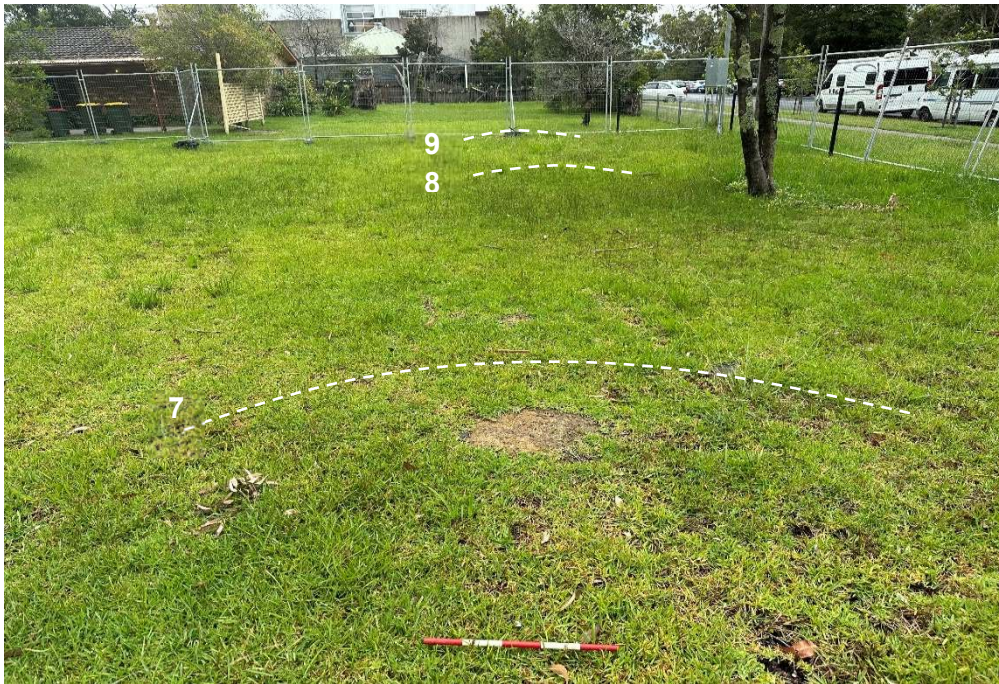
Figure 60. Examples of micro-rises of the ground surface (white dashed line) (width shown) in the northern portion of Lot 7, facing north.

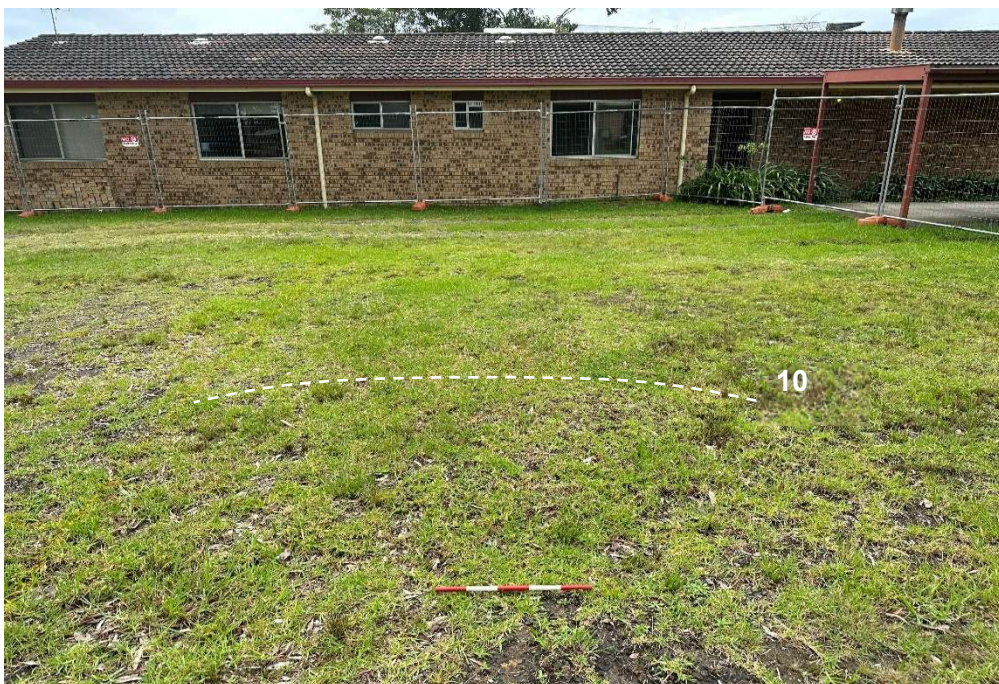
Figure 61. Examples of micro-rises of the ground surface (white dashed line) (width shown) in the northern portion of Lot 7, facing north.

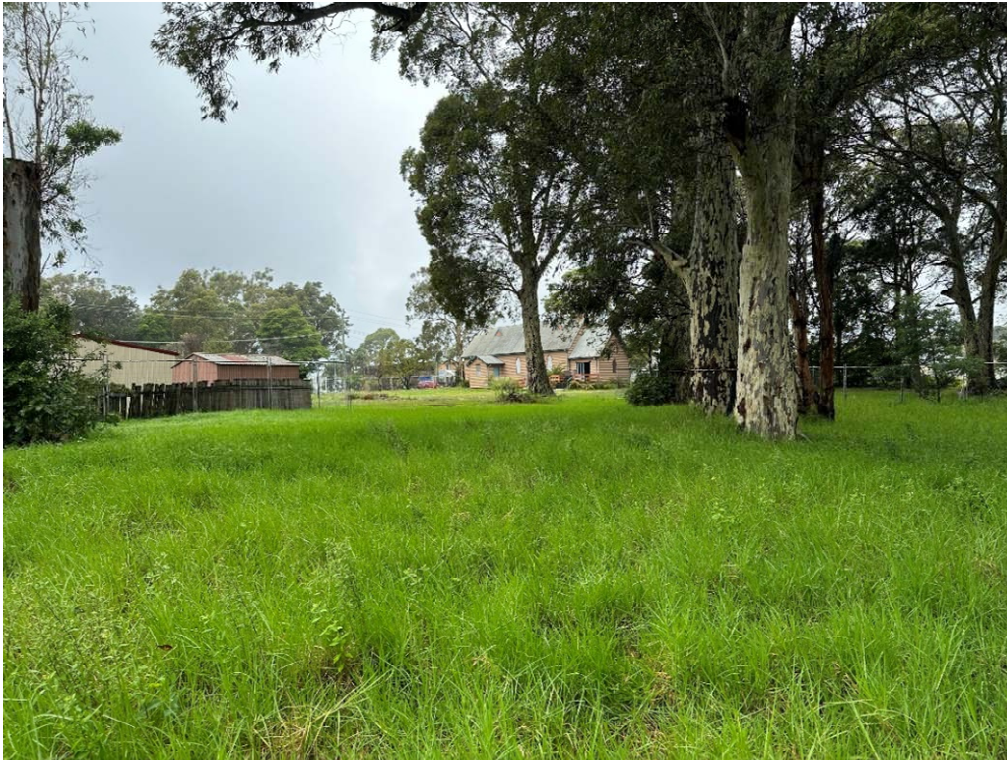
- Lot 8 was covered with thin tree cover (Figure 62).
- Lot 8 sloped gently down to the south (Figure 63).
- The ground surface in the northern portion of Lot 8 was heavily vegetated with long grass and leaf cover. As a result, the visibility (with the exception of a very small part of the path, as below) was 0–5 per cent (Figure 64 to Figure 66).

Figure 62. View through Lot 8, facing south-east.

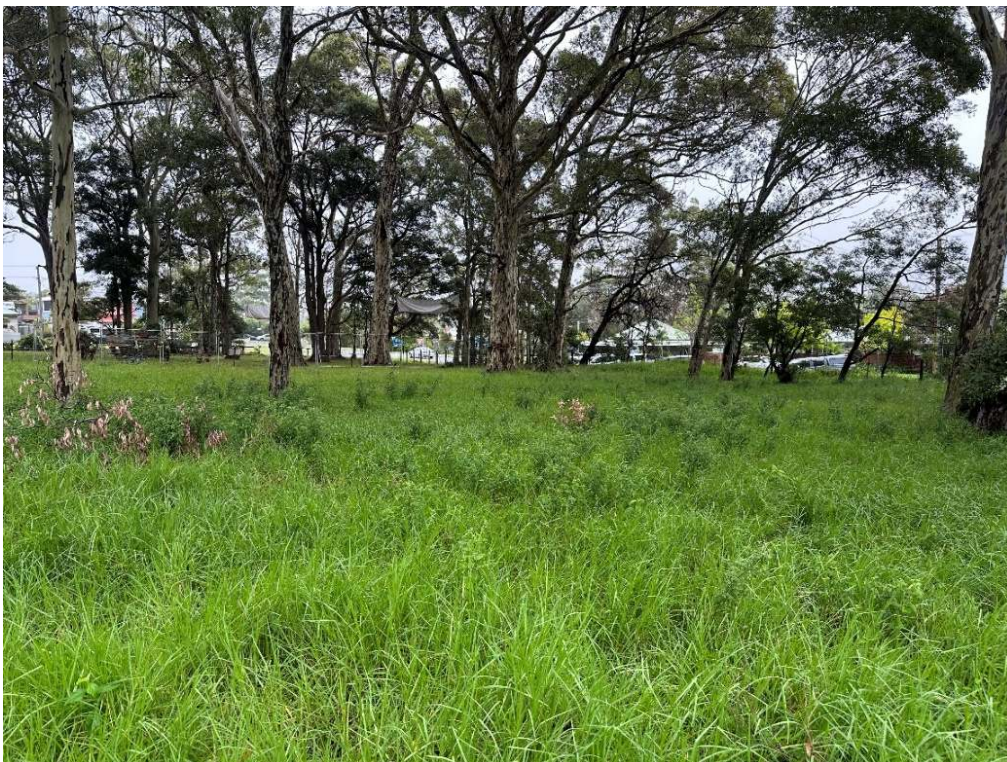
Figure 63. View through Lot 8, facing south-west.

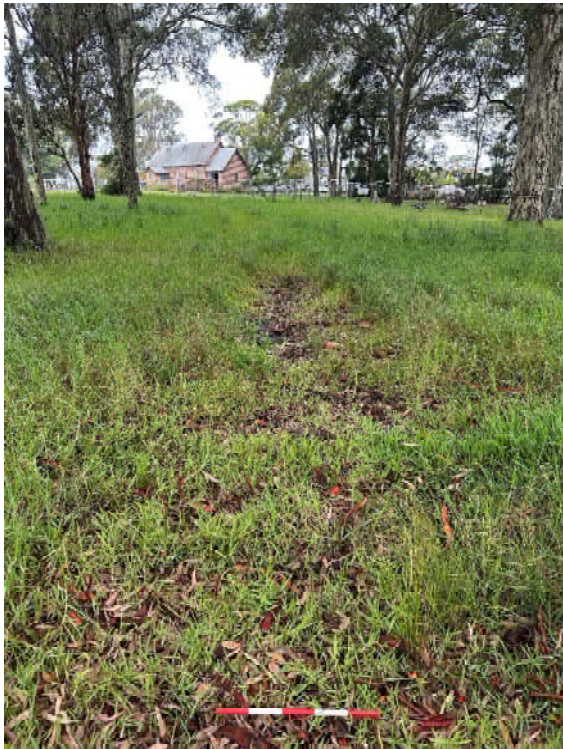
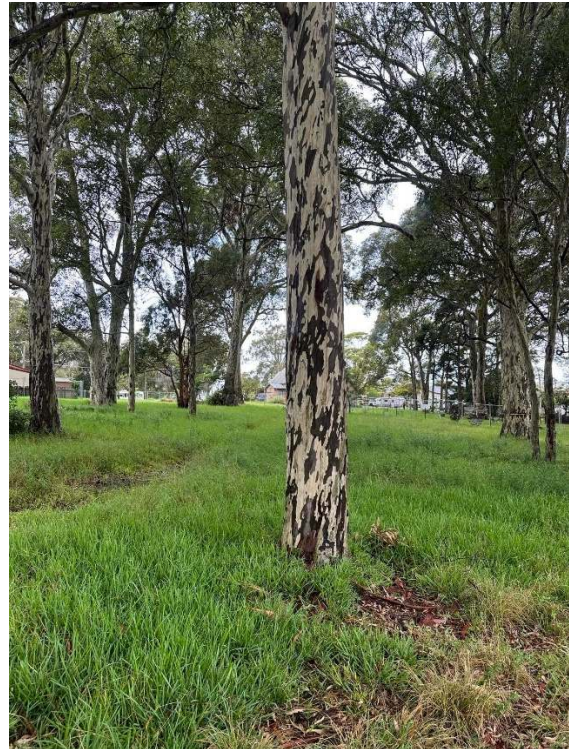
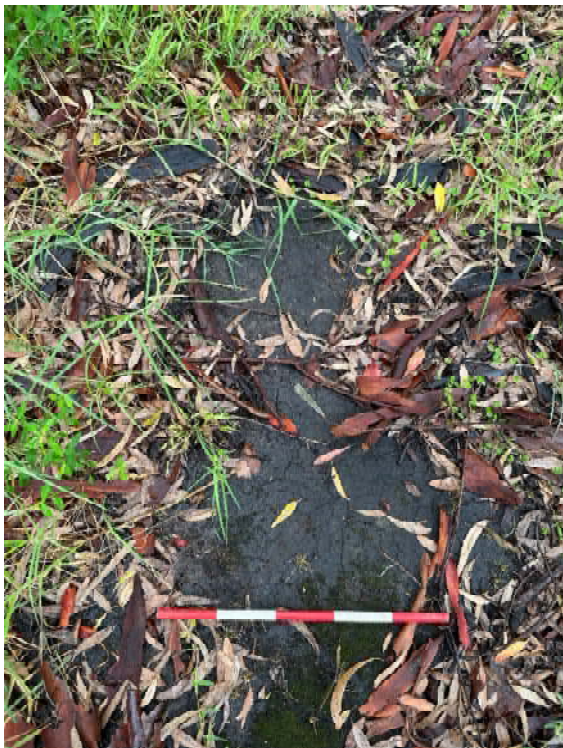
- A path ran diagonally through the centre of Lot 8, from the north-west corner to the south-east corner of the lot. The path had parts of exposed ground surface which showed the surface to comprise a clayey topsoil (Figure 64 to Figure 66).

Figure 64. Path through Lot 8, facing south-east.

Figure 65. Path through Lot 8, facing south-west.

Figure 66. Detail the path in Lot 8, facing south-east.

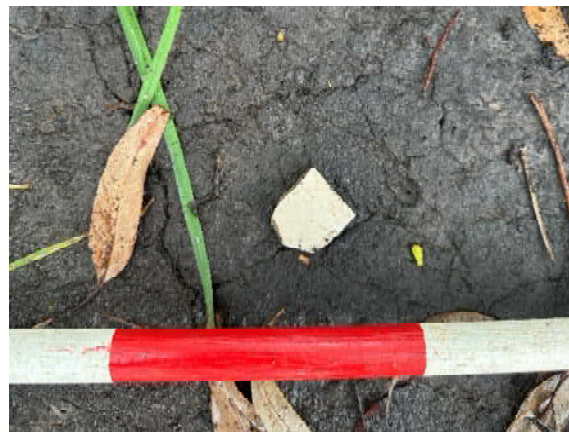
- One small piece of white ceramic (not collected) was identified on an exposed piece of ground surface on the path (Figure 67). Raised earth (likely caused by humic deposits and bioturbation) was identified around the base of larger trees (70).

Figure 67. Piece of white ceramic on the path through Lot 8.

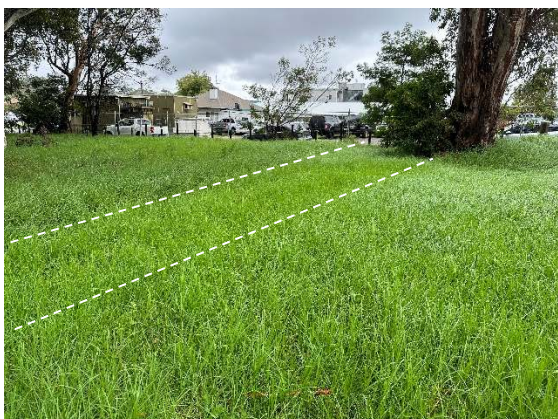
- A shallow divot, appearing to be a drainage channel, was located on the eastern part of Lots 8 and 9. The channel ran north to south (Figure 68 to Figure 69).

Figure 68. Strip of discoloured grass running north to south (white dashed line), likely associated with drainage (natural or manufactured) in the northern portion of Lot 8, facing north-west.

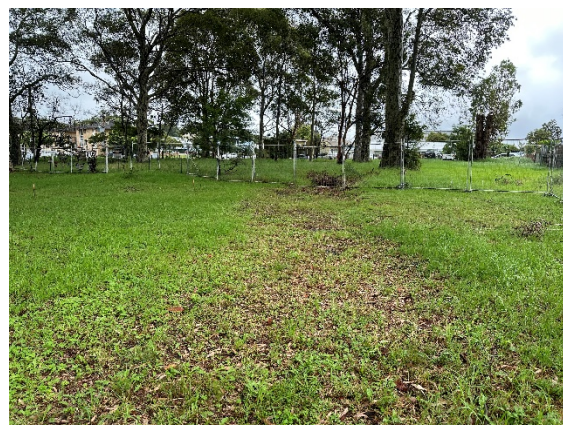
Figure 69. Strip of discoloured grass running north to south, likely associated with drainage (natural or manufactured) in the southern portion of Lot 8, facing north.

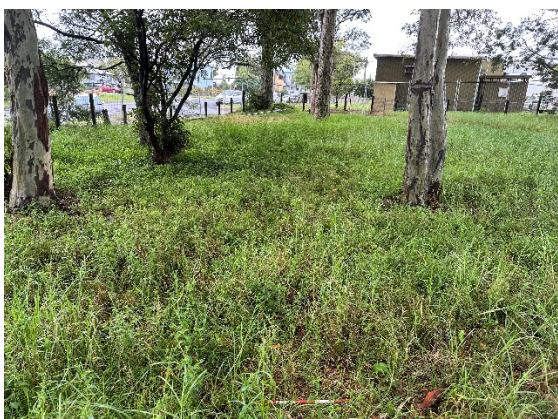
- The ground in the area at the southern boundary of Lot 8 was slightly undulating under foot (Figure 70).

Due to the high grasses and other vegetation, a comprehensive assessment of the ground surface could not be completed. Some areas of undulating ground were identified within Lot 8. These were more likely to have been produced by bioturbation and roots, rather than associated with graves, as they were located close to large trees or clusters of trees.

Figure 70. Area of undulating ground between trees in the south-western corner of Lot 8, likely due to bioturbation and roots, facing north.

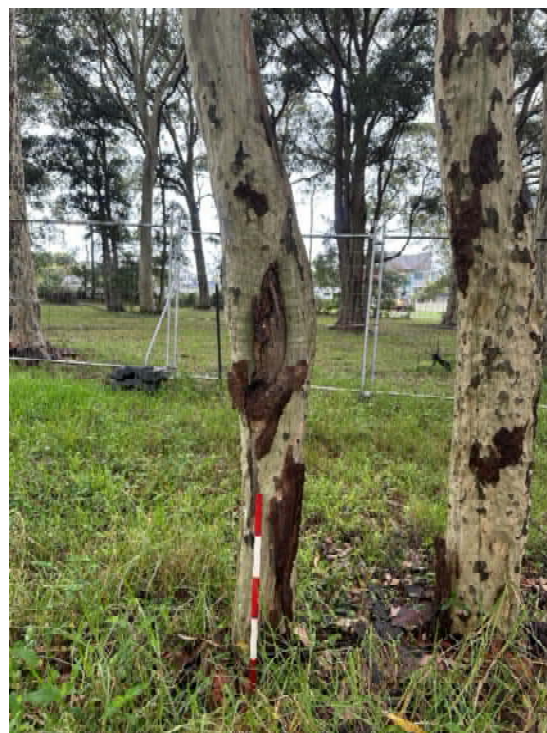
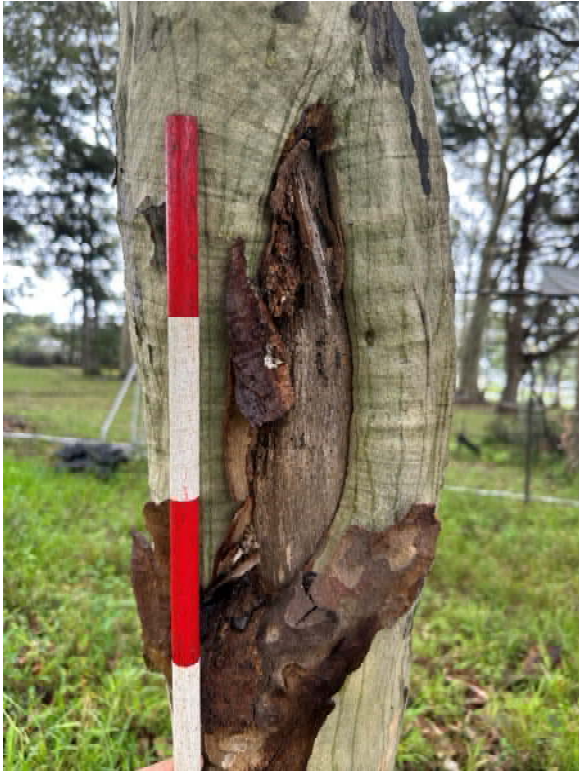
A thin tree located in the south-west corner of Lot 8 contained a small oval shaped scar with a pointed apex on the top and bottom end (Figure 71 and Figure 72). The scar measured 290 mm tall and 70 mm at its widest point. The depth of the scar was approximately 25 mm deep and the base of the scar was 770 mm from the ground surface. The scar curved around the tree trunk. Based on the size of the tree and associated approximate age of the tree, and the curved nature of the feature, it is unlikely to be culturally modified by Aboriginal people.

Figure 71. Tree in Lot 8 with a scar, facing south.

Figure 72. Detail of tree in Lot 8 with a scar, facing south.

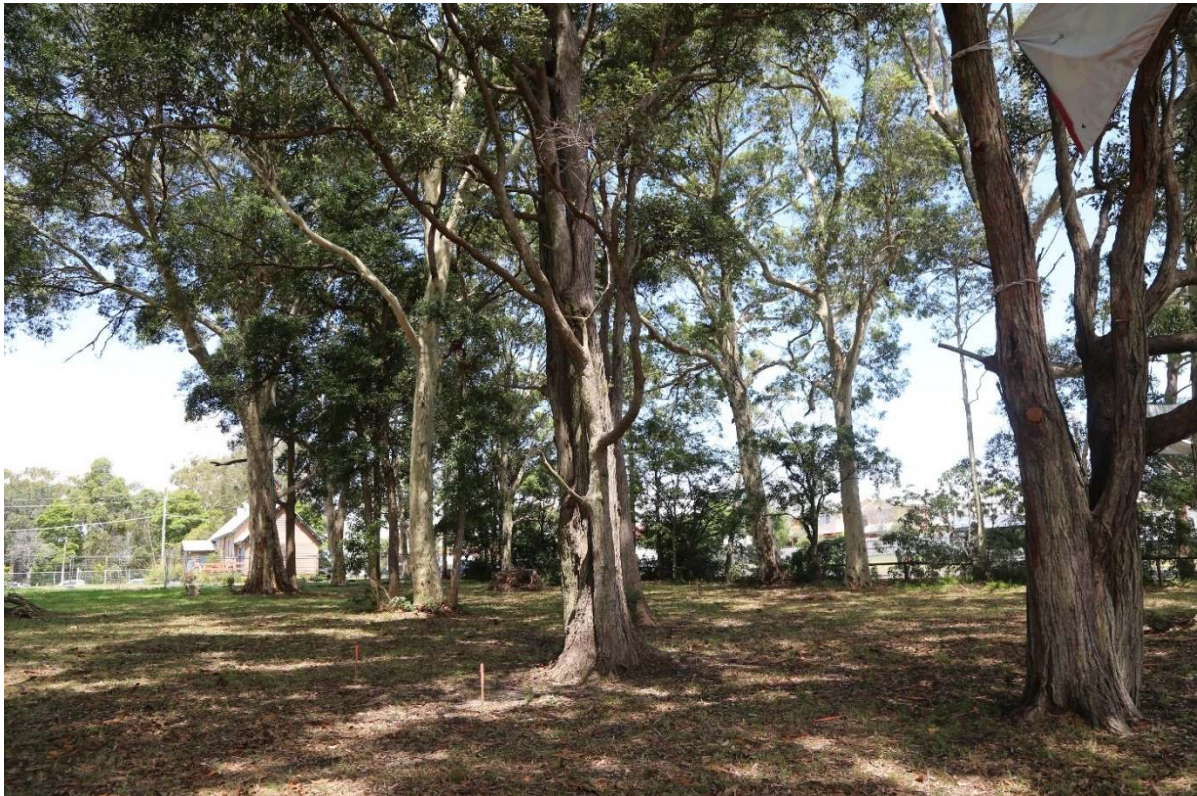
- Lot 9 sloped gently down to the south (Figure 75).
- Lot 9 was covered with thin tree cover (Figure 73 and Figure 76).
- The ground surface in the northern portion of Lot 9 was covered with grasses (predominantly eastern half) and leaf cover (predominantly western half). As a result, the visibility averaged 0–5 per cent across the Lot (Figure 73 to Figure 76).
- No archaeological relics were identified above the ground surface.
- No historical archaeological features or natural landscape features identified during the site visit indicated the presence of graves or other historical archaeology within Lot 9.

Figure 73. View east through Lot 9, former Huskisson Anglican Church visible at left, facing south.

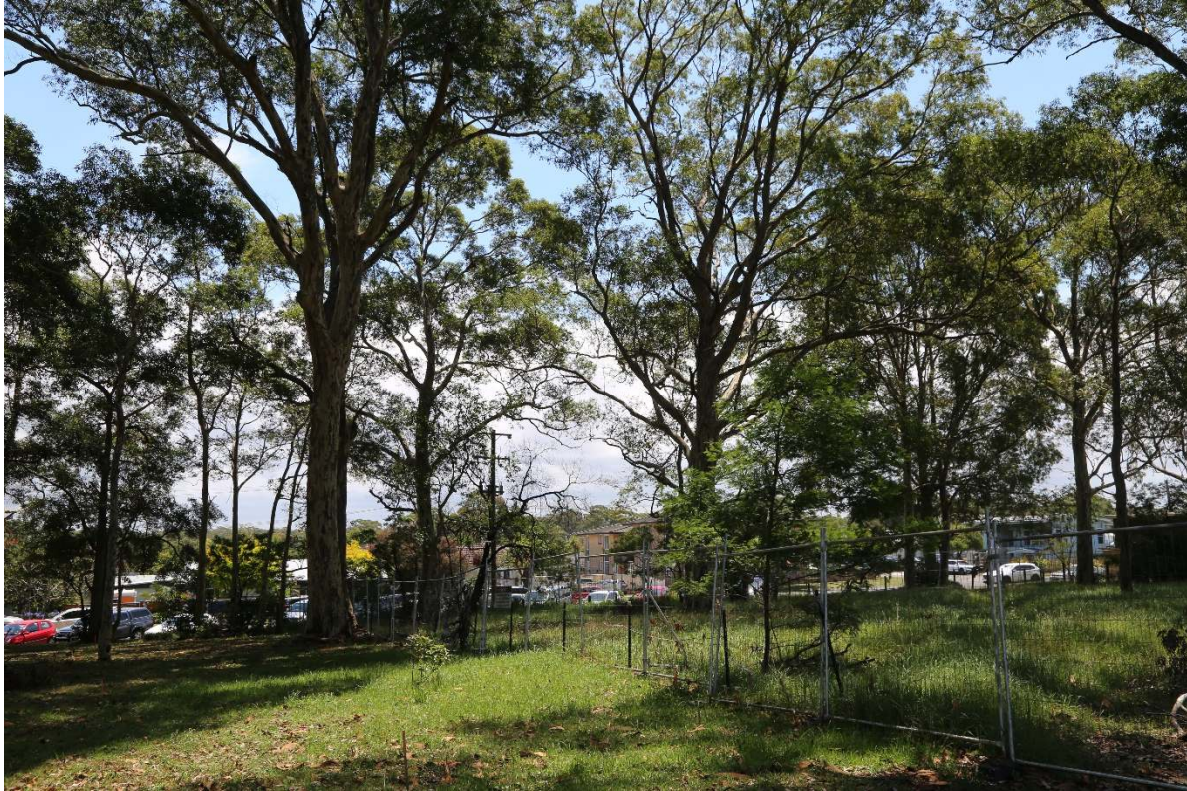
Figure 75. Boundary between Lot 9 (left) and Lot 8 (right), facing west.

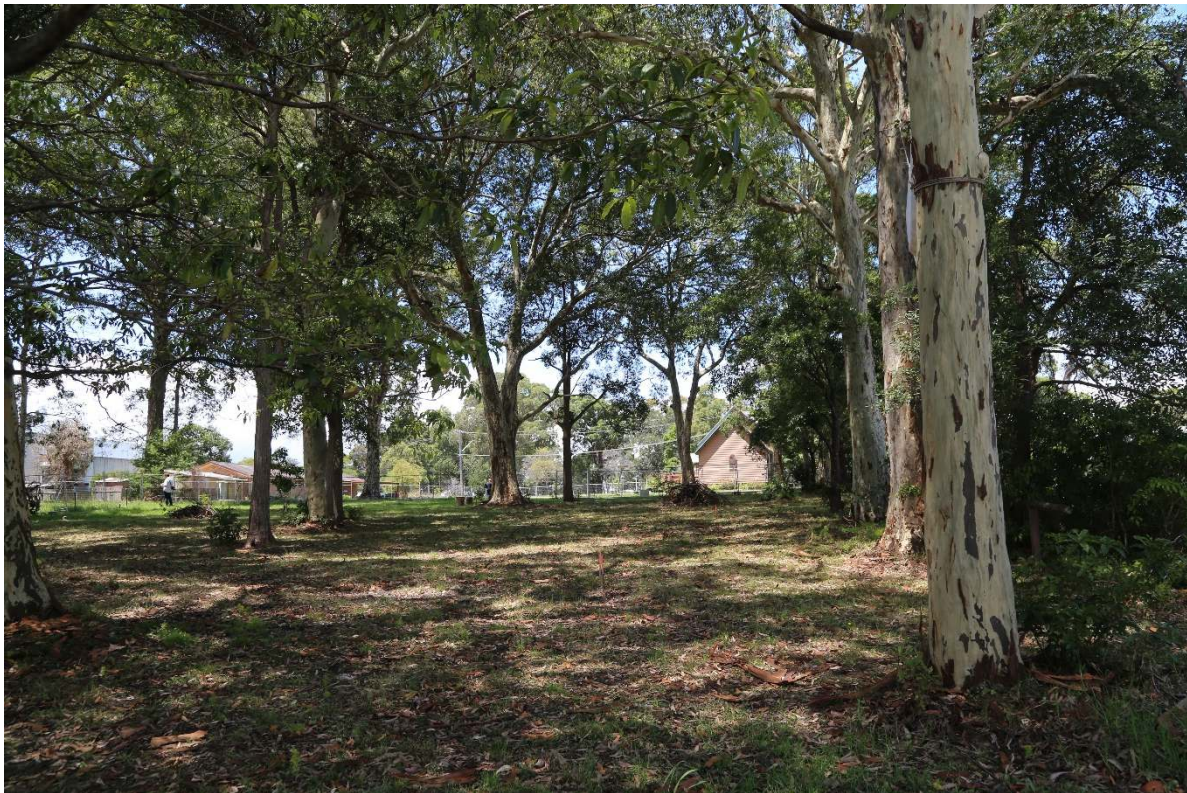
Figure 76. View through Lot 9, facing east.

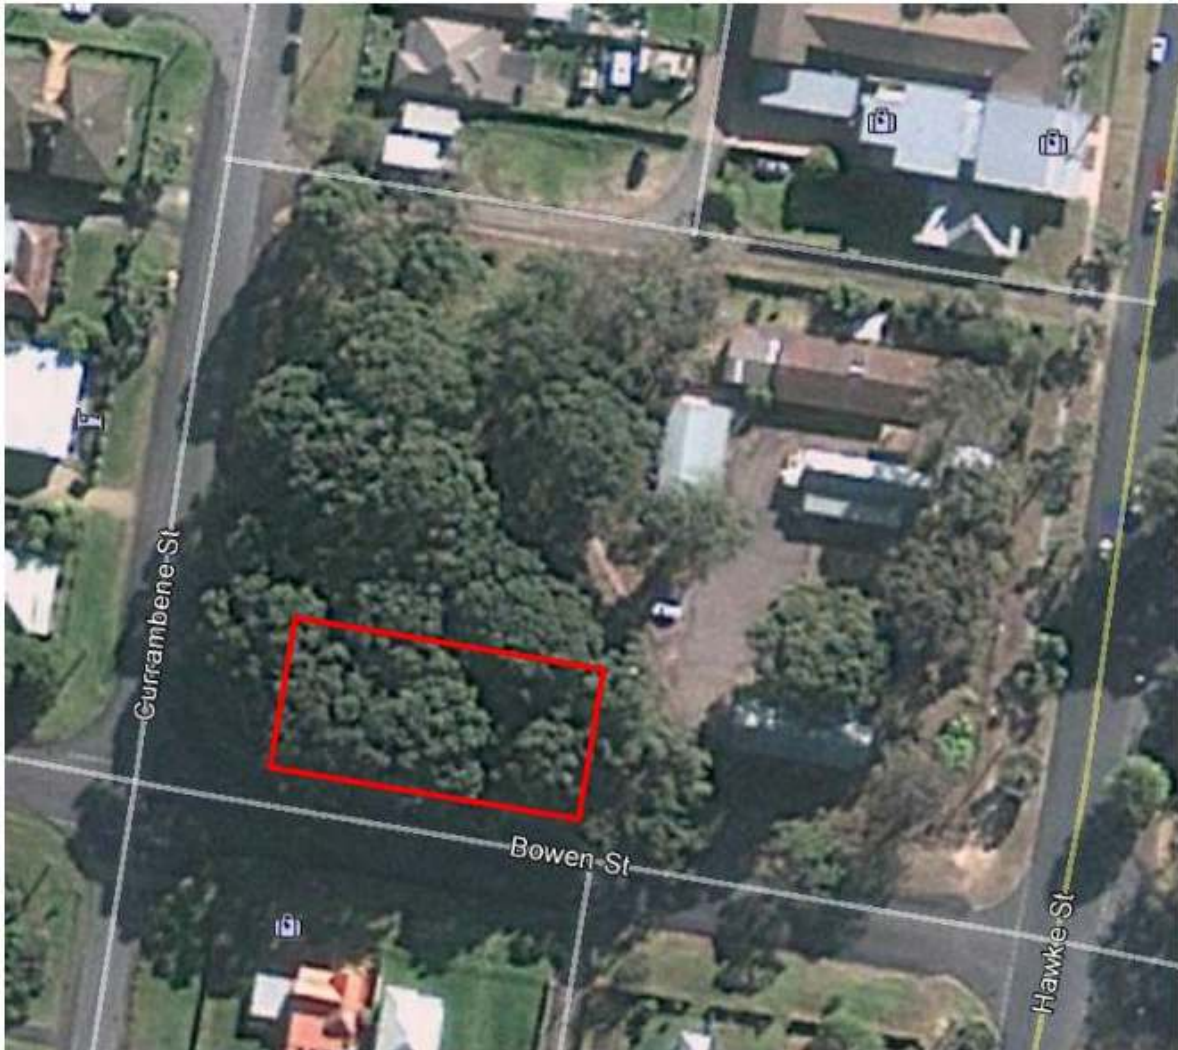
Figure 83. 2015 area of GPR survey shown outlined in red, outside of the present-day site. *Source:* GBG Australia 2015, 'Non-destructive subsurface investigation using ground penetrating radar to locate unmarked grave sites at the former Huskisson Anglican Church Ground, Huskisson, New South Wales

The 2015 GPR survey was undertaken in Lot 9, outside of the site (Figure 83). A total of seven possible unmarked graves were identified within the survey area. The report noted that the data collected was of moderate quality with a low signal to noise ratio, likely due to damp conditions and clay content in the subsurface. The report also noted that several anomalies identified as possible grave sites were located close to large trees and as such could be the result of root systems.
