Former Huskisson Anglican Church

Statement of Heritage Significance

Prepared for Shoalhaven City Council

May 2023 - FINAL

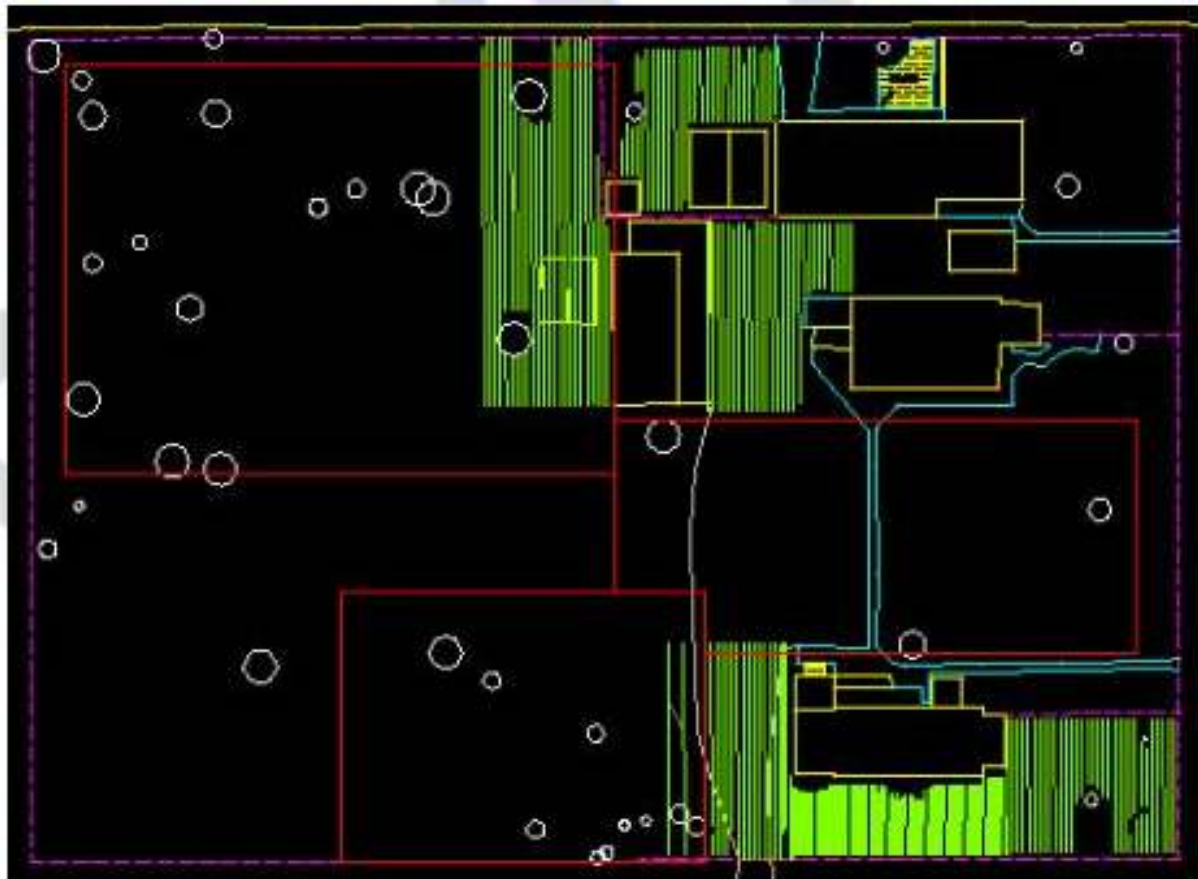
Figure 84. Drawing of the area surveyed in April 2019, shown with green lines. *Source:* GBG Australia, 2019a, 'Huskisson Anglican Church-Unmarked Graves GPR Survey'.

The report concluded that there was evidence for one grave near the church building, with another possible two graves in proximity. No evidence for graves were found to the west of the rectory building or in the area between the rectory and church hall (old church building) or beneath where the metal shed had been located.

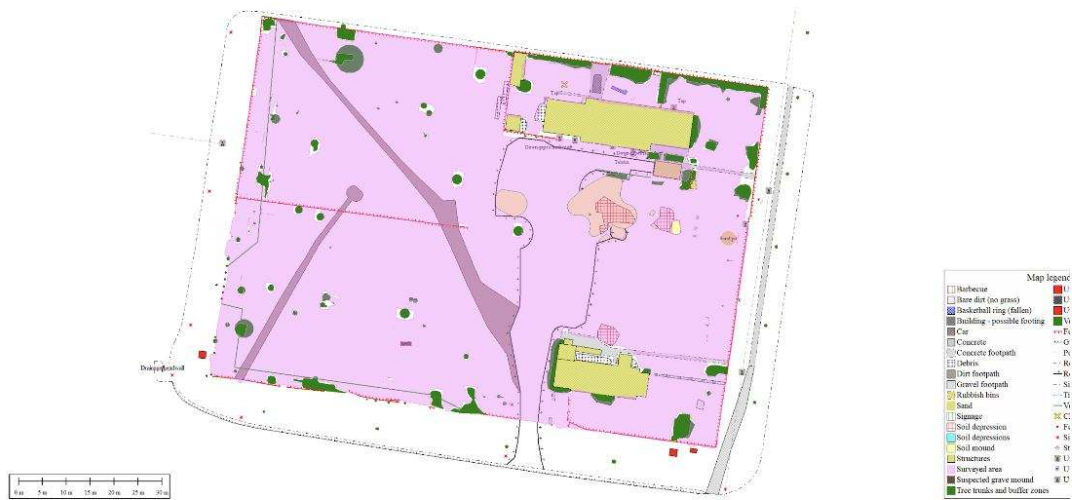
Figure 87. Map showing the area covered by the 2021 survey. *Source:* Hunter Geophysics, 2021, 'Geophysical Survey Report Former Anglican Church Site in Huskisson'.

The survey located a total of seventy-three anomalies across the site that were interpreted as likely being associated with unmarked grave shafts and/or funerary urn burials (Figure 88). The anomalies were of varying size, depth, and orientation. The report recommended expanding the survey to Bowen Street nature strip but otherwise made no further recommendations.

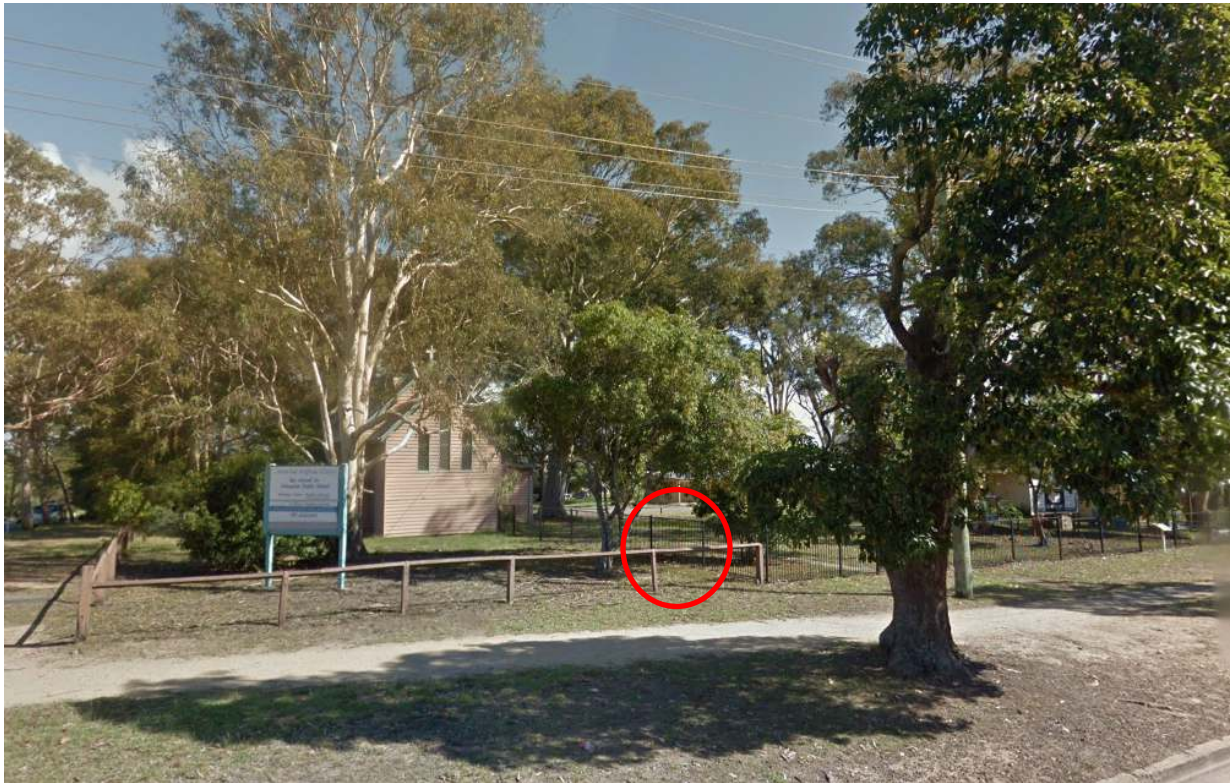
Figure 103. View to metal shed from Hawke Street. Metal shed indicated red (Source: Google Streetview 2018).

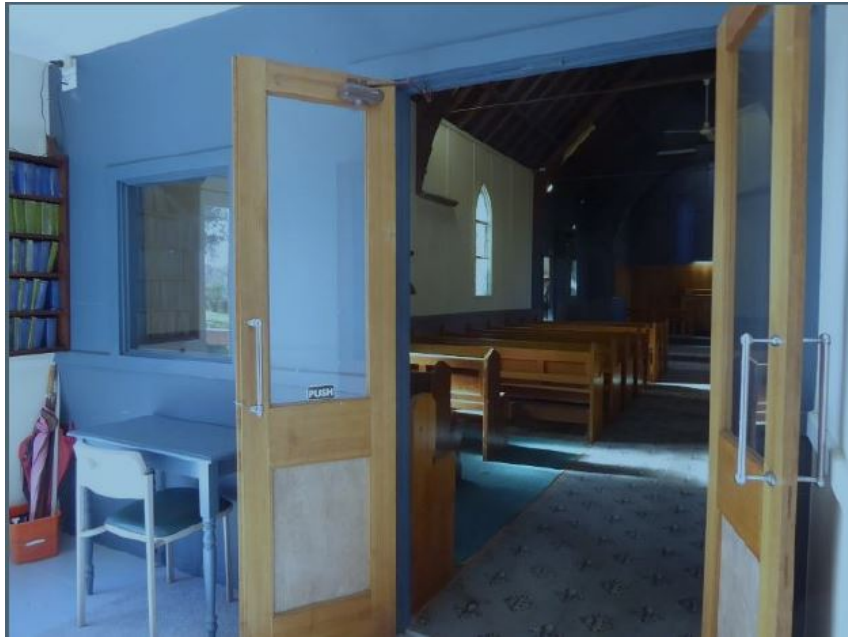
Modern doors and viewing windows from the new porch. (Source: Save Husky Church Group)

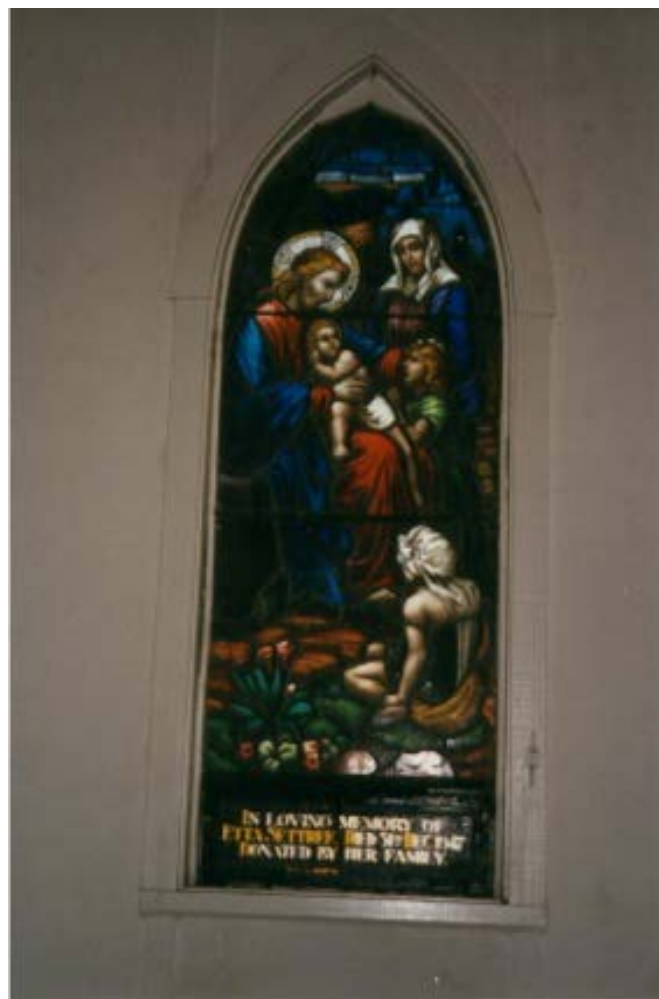
Memorial window (Source: Save Husky Church Group)

In 1947 parishioner Henrietta Setttee died and Alfred Setttee, local boat builder had a stained glass window made in memory of his wife. In 1953 the stringy bark split shingled roof was replaced with a galvanised iron roof by local builder Bob Martin. In the 1970s the original structure (the hall) was relocated southwards to make way for a new rectory. At this time the building was modified with a large addition to the west, doubling its length. A further addition to the west provided a large kitchen area, an addition to the east provided additional hall space and an external toilet block was added to the west. After 2000 a large southern verandah was added to the hall building.

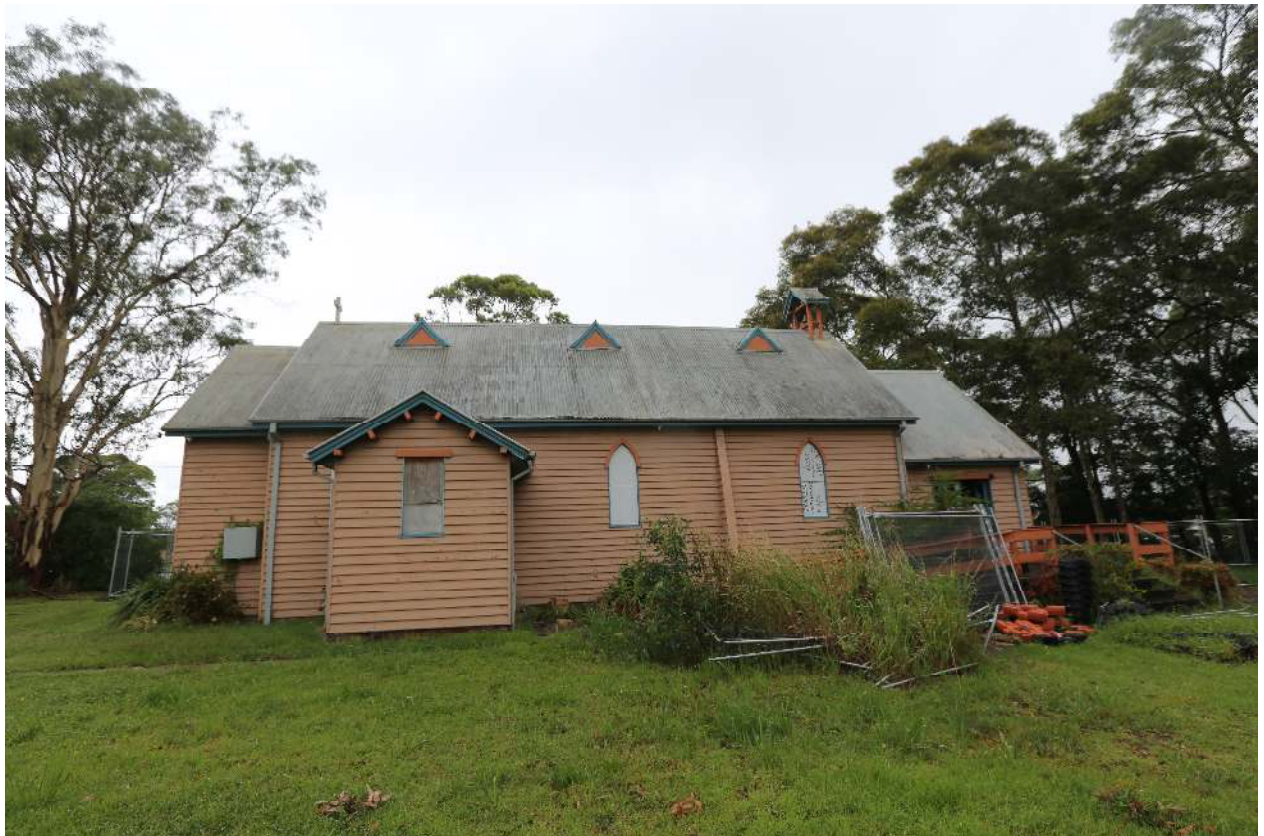
| Image caption | Northern elevation | | | | |

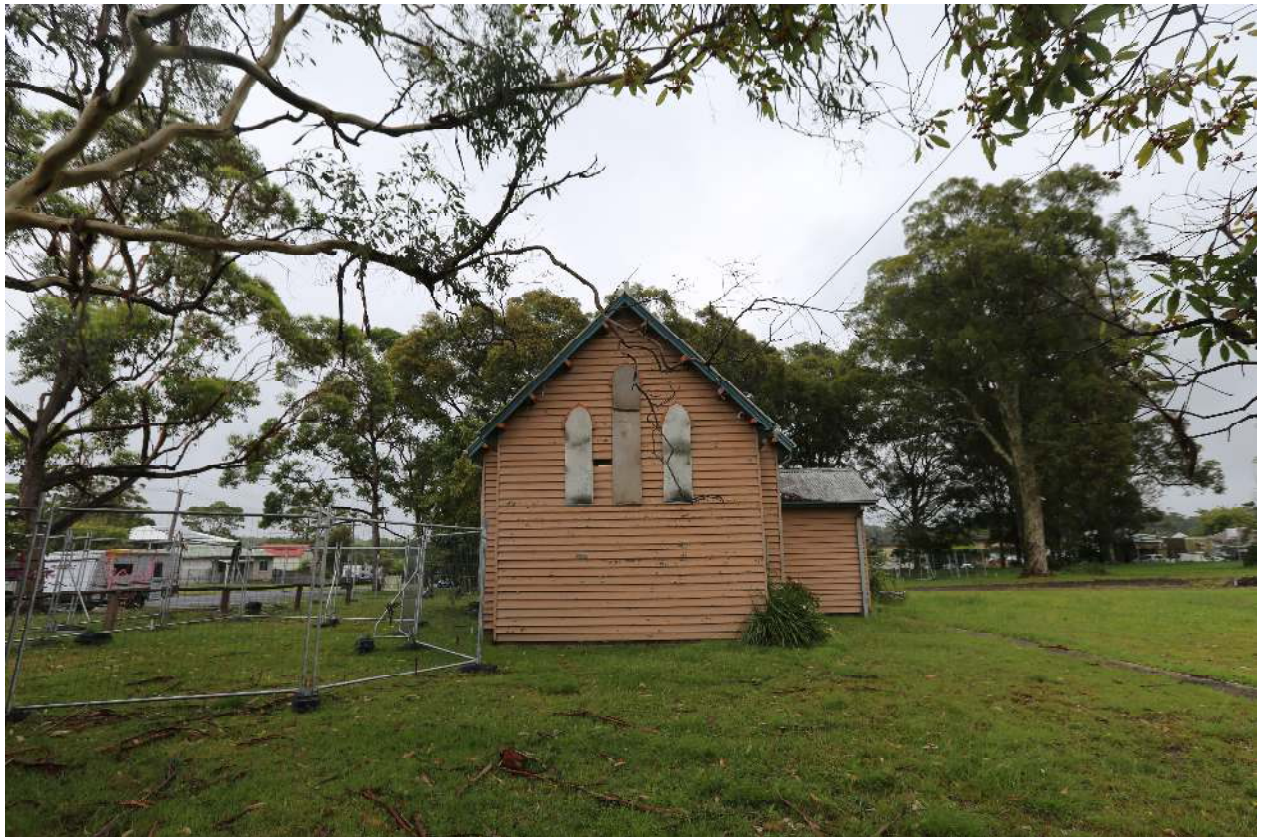
| Image caption | Eastern elevation | | | | |

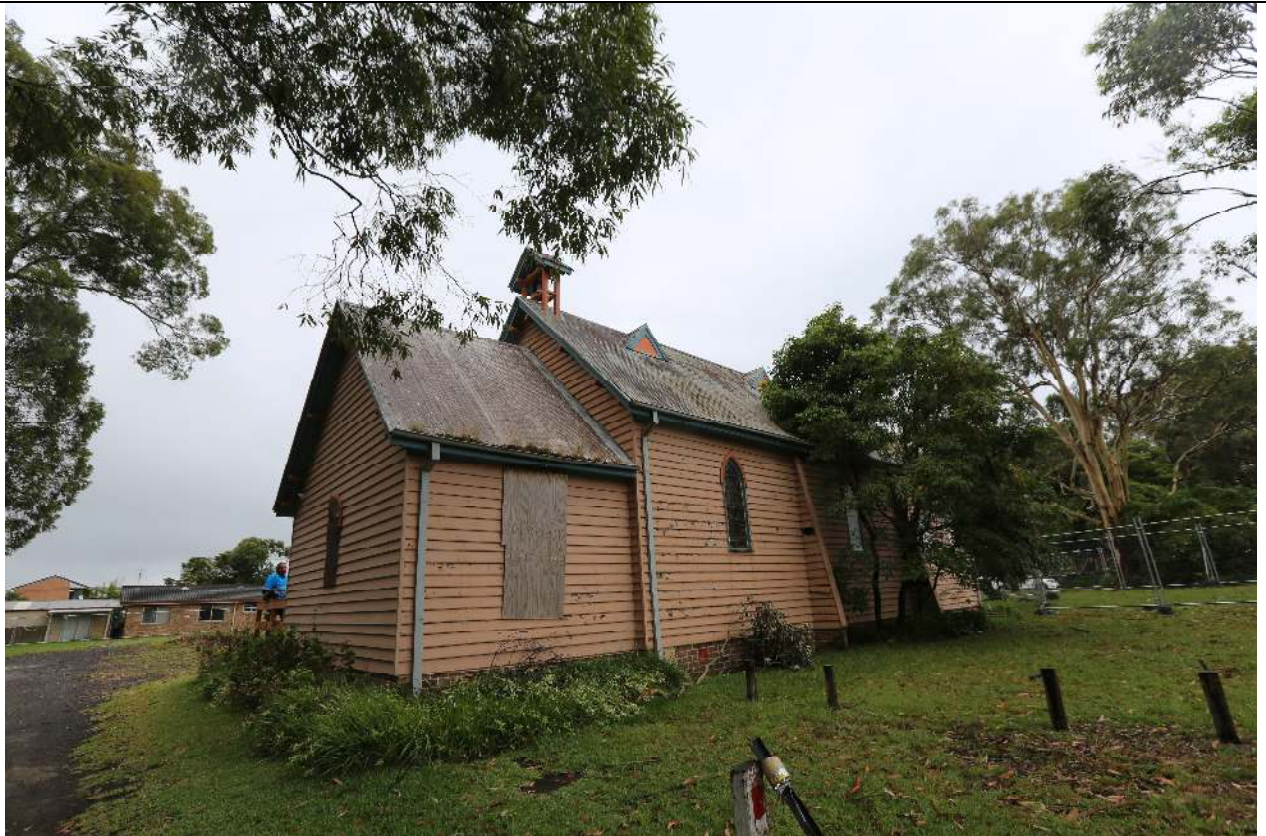
| Image caption | Southern elevation | | | | |

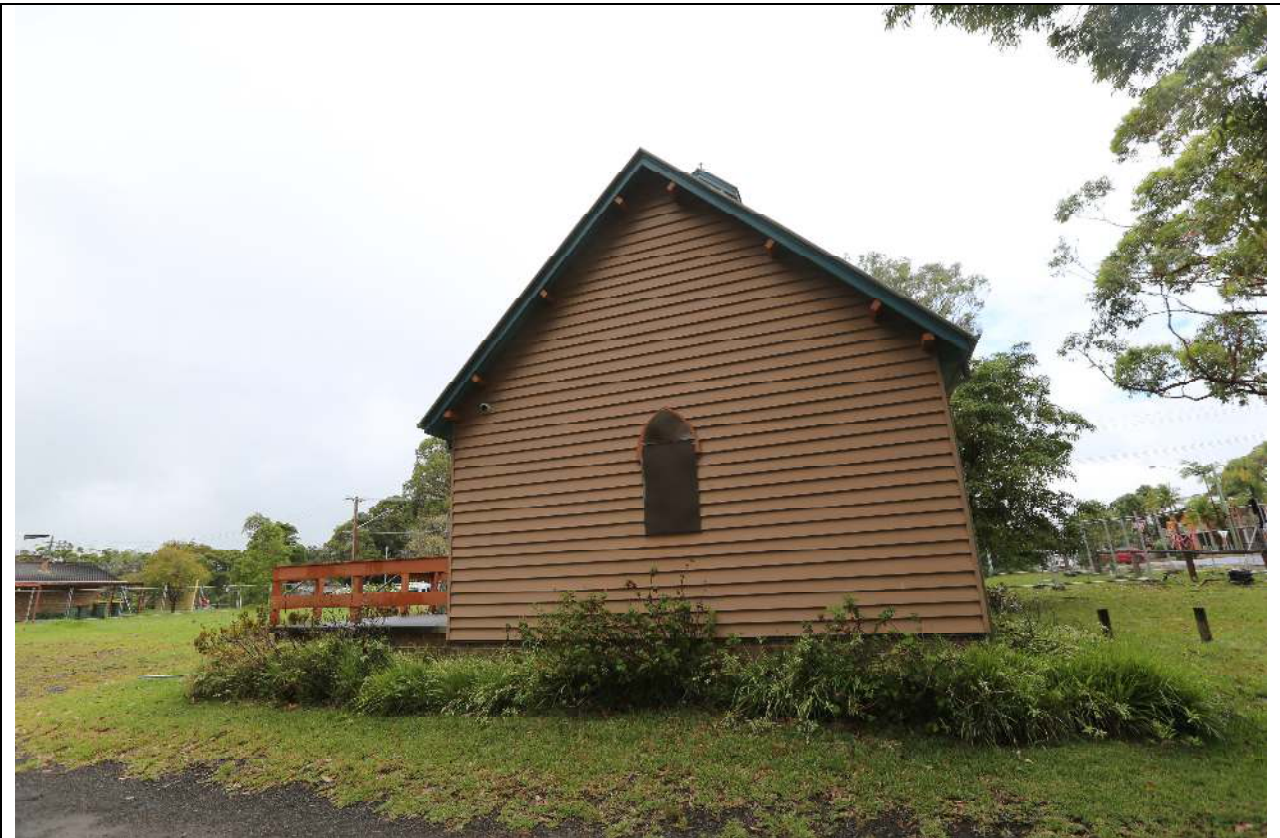
| Image caption | Western elevation | | | | |

| DESCRIPTION | |
|---|---|
| Physical condition and Archaeological potential | <p>Physical condition Overall, the 1931 church building is in fair condition. The building retains much of its original fabric. Later additions include the western porch and replacement corrugated roof cladding. These additions are sympathetic to the building, and do not detract from the Carpenter Gothic design of the church building.</p> <p>External paintwork was observed to be flaking across several areas, particularly to the eastern and southern elevations. External cladding is damaged or missing in several areas, including to the eastern elevation, the south-eastern corner, and the southern elevation. Internal walls, ceiling and flooring are in good condition. Windows to the western porch have broken glazing.</p> |

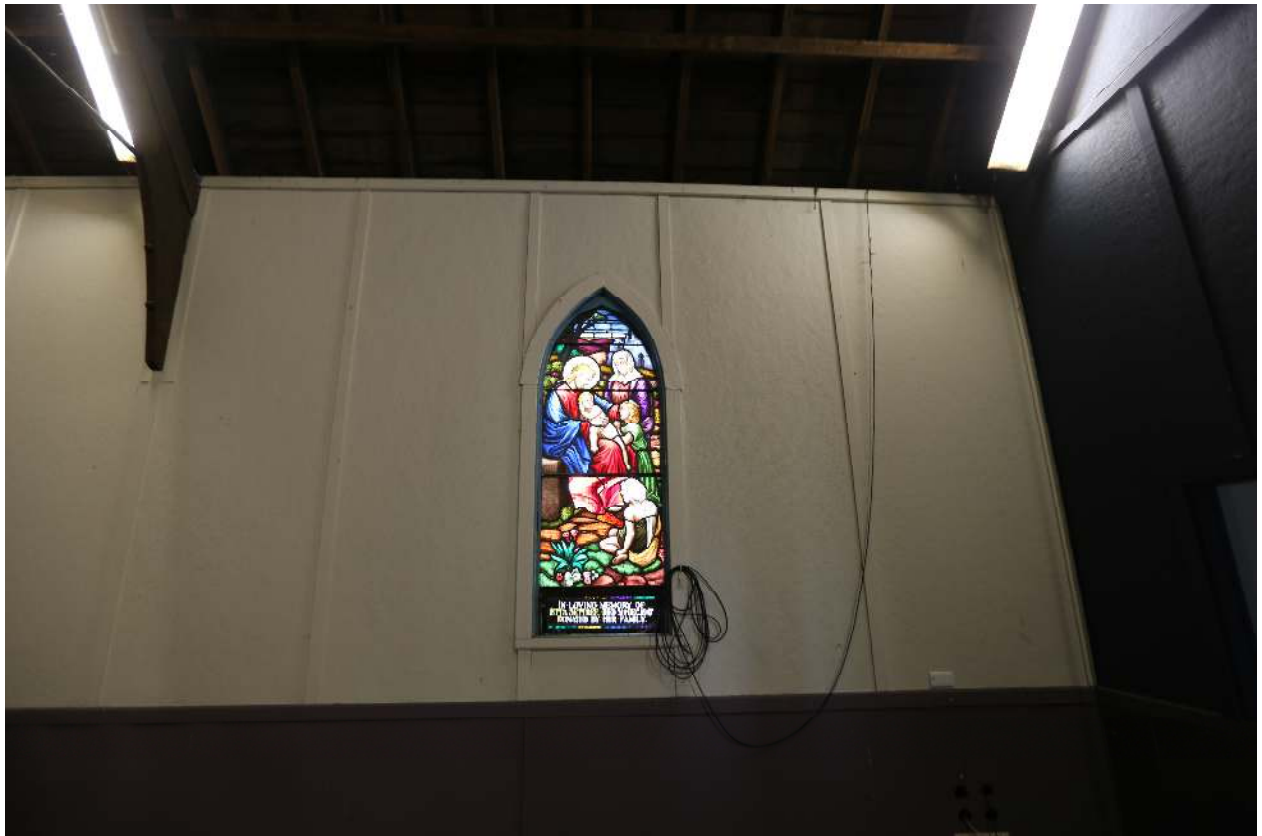
| Image caption | Interior – stained glass window | | | | |

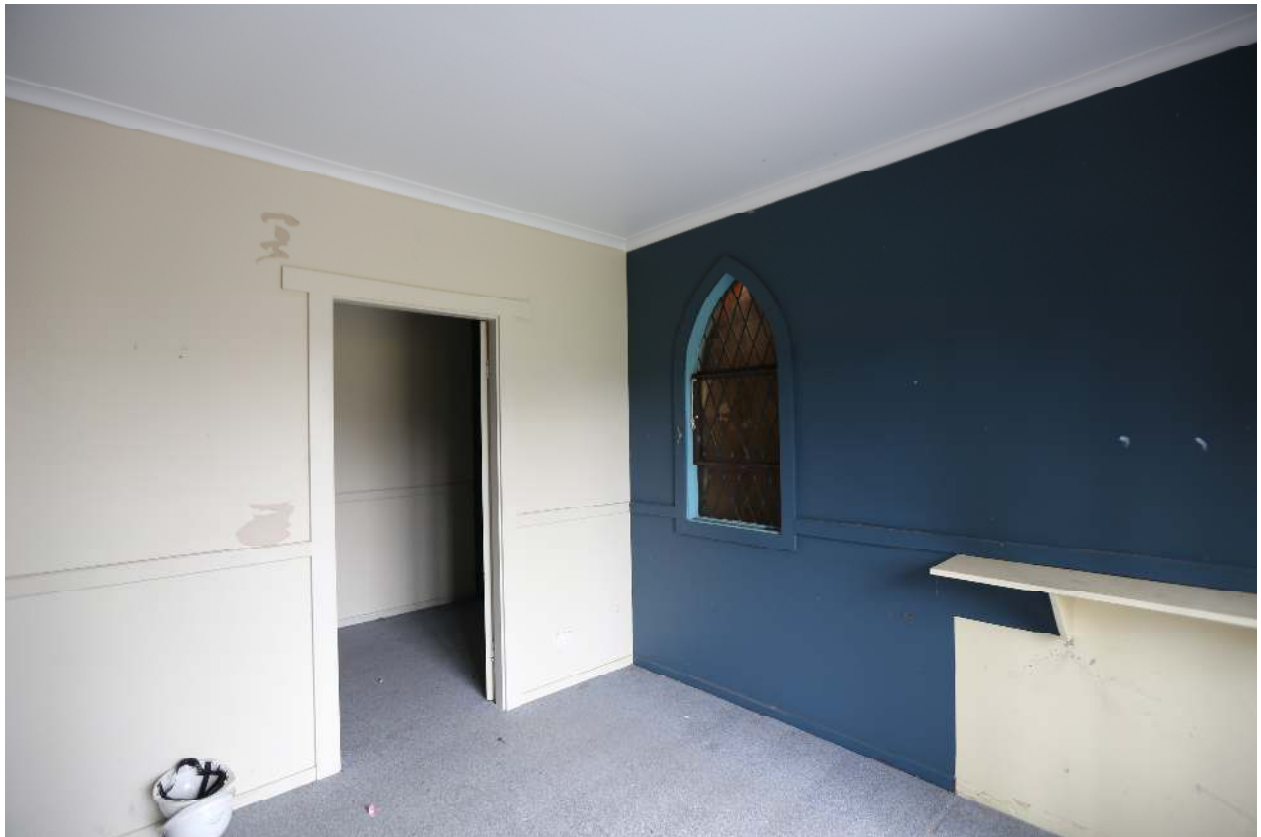
| Image caption | Interior - porch | | | | |

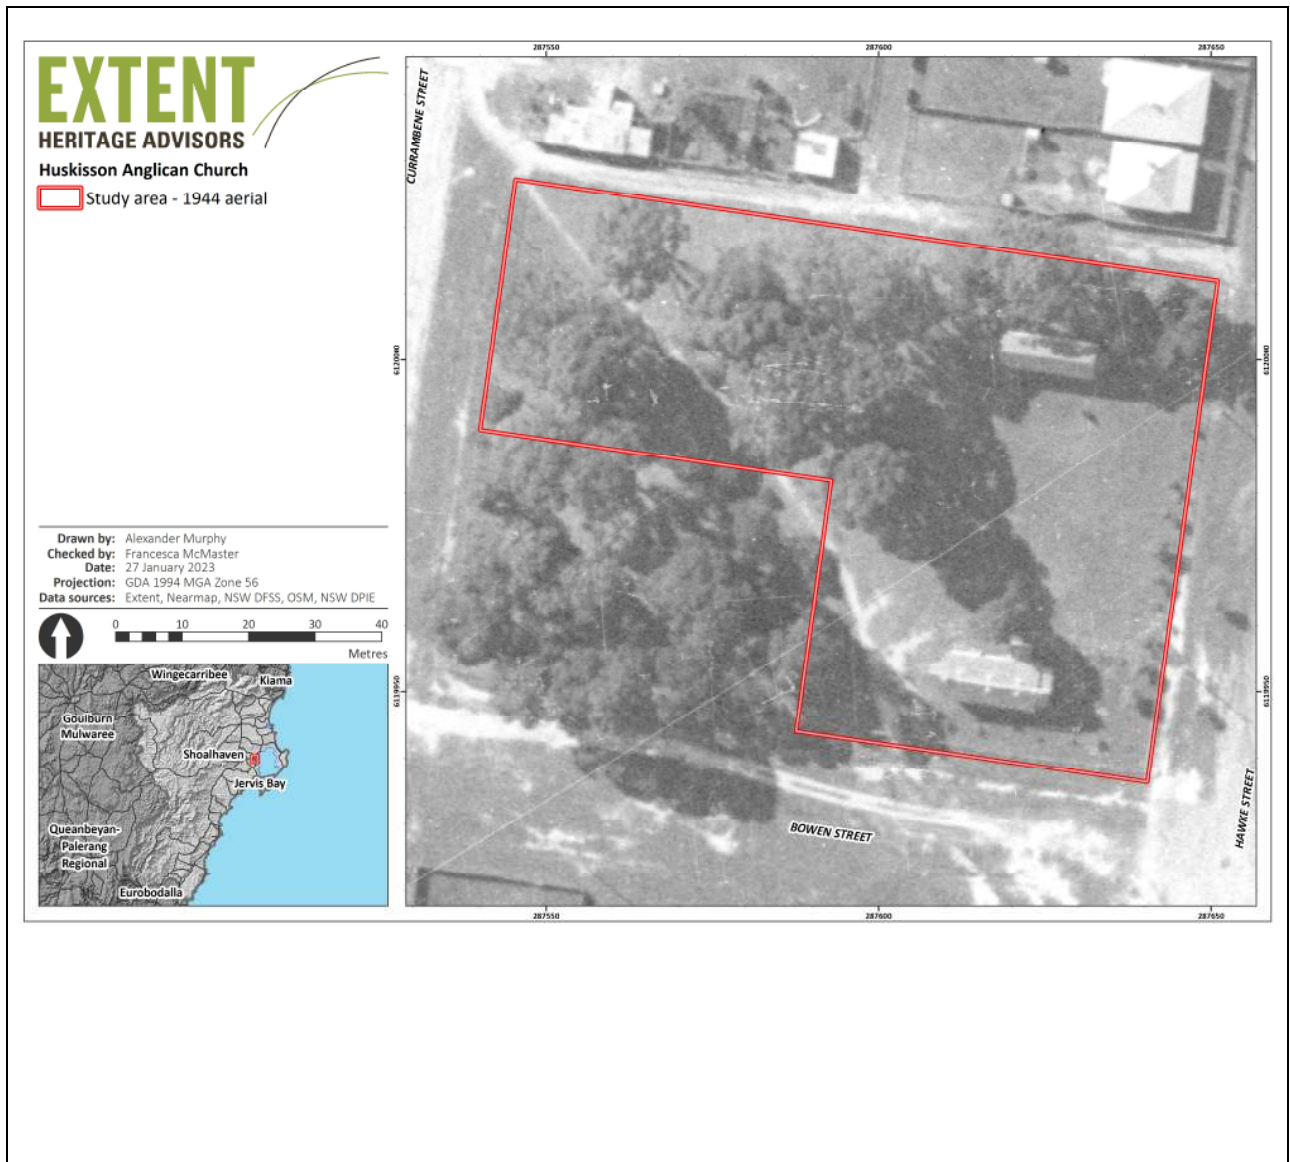
| Image caption | 1944 aerial image showing the 1931 church building in its current position and the c. 1905 church in the north-eastern corner of the site. | | | | |

| | 1956 – Timber shingle roof to current church replaced with corrugated sheeting 1979 – Original church relocated south for construction of rectory building c.1980-2000 – Western porch added to current church 2019 – Original church building and later metal shed demolished |
